# **PERFORMANCE TEST REPORT**

- REPORT NO.: 2407.01-110-21-R1
- RENDERED TO: TRUE BLUE PRODUCTS Redding, California
- PRODUCT TYPE: Continuous Insulation Mounting Systems

**PRODUCT TYPE:** Continuous Insulation Mounting Systems

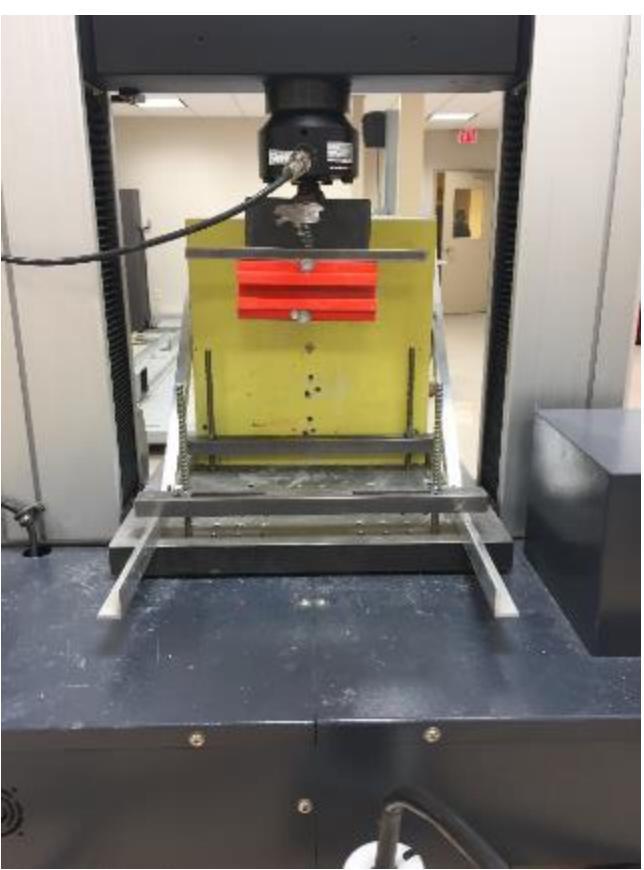
Photo No. 1 - 3" TRUE CI H-GIRT (Typical Setup)

One specimen for each of the 2-1/2" and 5-1/2" TRUE Ci H-GIRT sizes were tested at the 2" and 4" insulation thicknesses. Also, one specimen at the 2" and 4" insulation thicknesses was tested for the TRUE Ci V-GIRT. All specimens were attached to a 12" x 12" wall section fabricated from 16 ga., 6" steel studs sheathed with Densglass. All specimens were tested without insulation between the Girt and the Densglass. All specimens installed to simulate 2" insulation utilized 1/4" diameter x 5" long hex head self-drilling screws and all specimens installed to simulate 4" insulation utilized 1/4" diameter x 8" long hex head self-drilling fasteners.

The specimens were loaded into a Test Resources universal test machine Model 312 Series Frame with a Q Controller (Asset #00217). A vertically downward load was applied at a rate of 0.10 inches per minute utilizing a 5-1/4" by 2" by 5/16" steel plate that was affixed into a 5600 lbf load cell (Asset #00226). In order to distribute load onto each specimen, a 10-1/4' by 1/2" by 1/2" flat steel bar was used for the TRUE Ci H-GIRT specimens and a 4-1/2" by 1" by 5/8" flat steel bar was used for the TRUE Ci V-GIRT specimens.

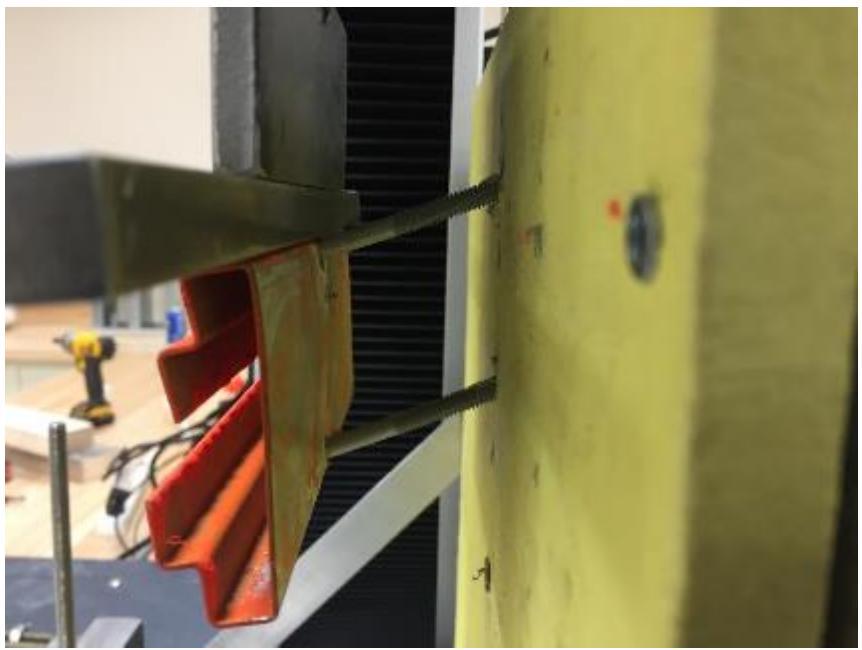
Photo No. 2 - 3" TRUE CI H-GIRT (Typical Failure)

Each specimen had a pre-load applied between 5.0 lbf and 8.0 lbf in order to stabilize each specimen. The machine was then zeroed out and the testing was started. Testing was terminated once the bolts were determined to have yielded significantly.

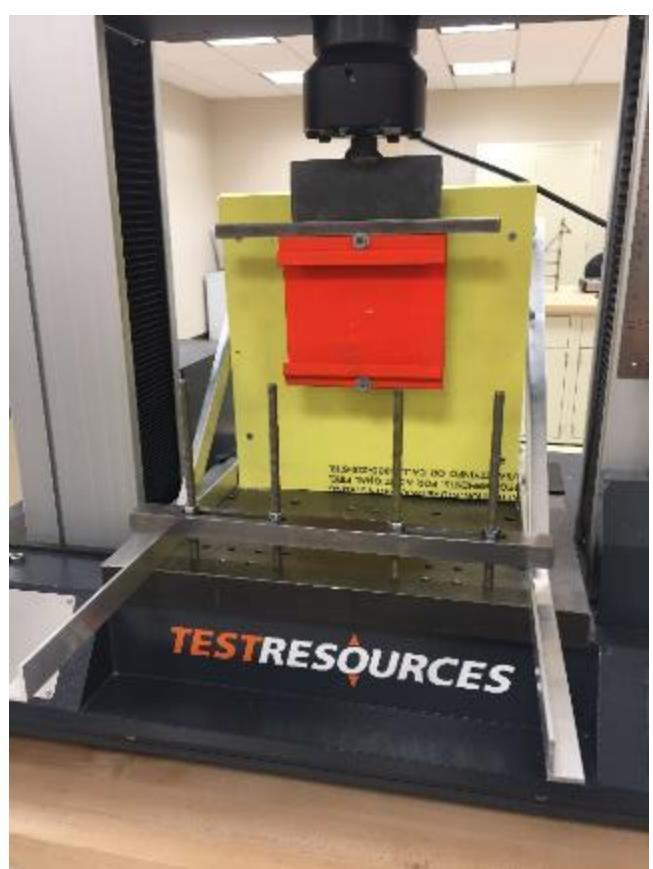
Photo No. 3 - 6" TRUE CI H-GIRT (Typical Setup)

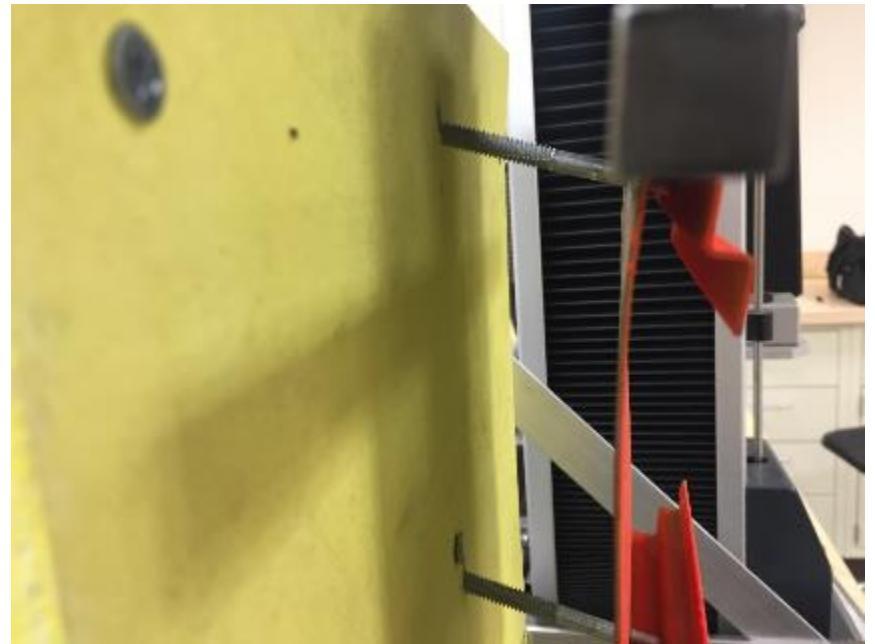
Photo No. 4 - 6" TRUE CI H-GIRT (Typical Failure)

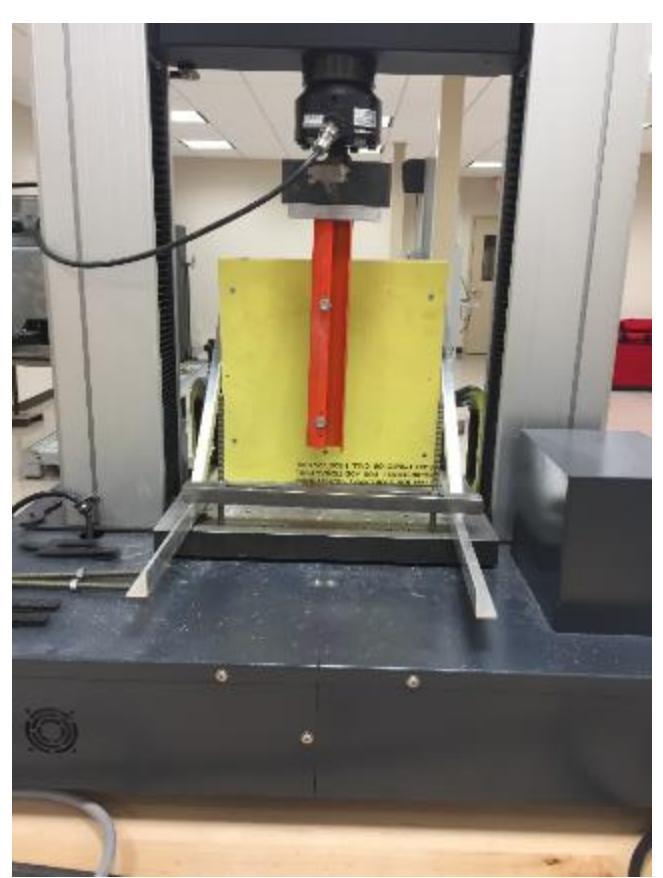
Photo No. 5 - TRUE CI V-GIRT (Typical Setup)

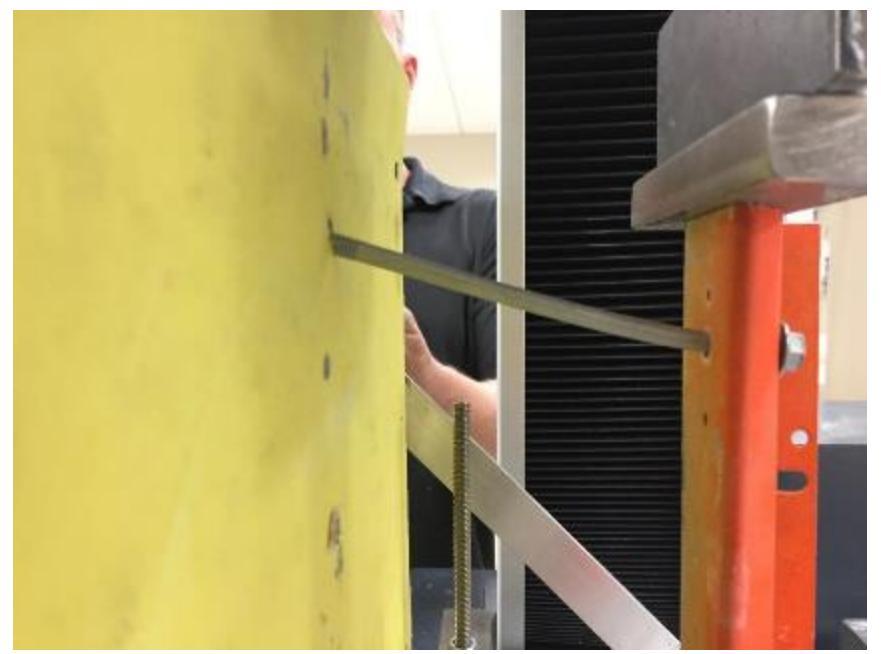
Photo No. 6 - TRUE CI V-GIRT (Typical Failure)

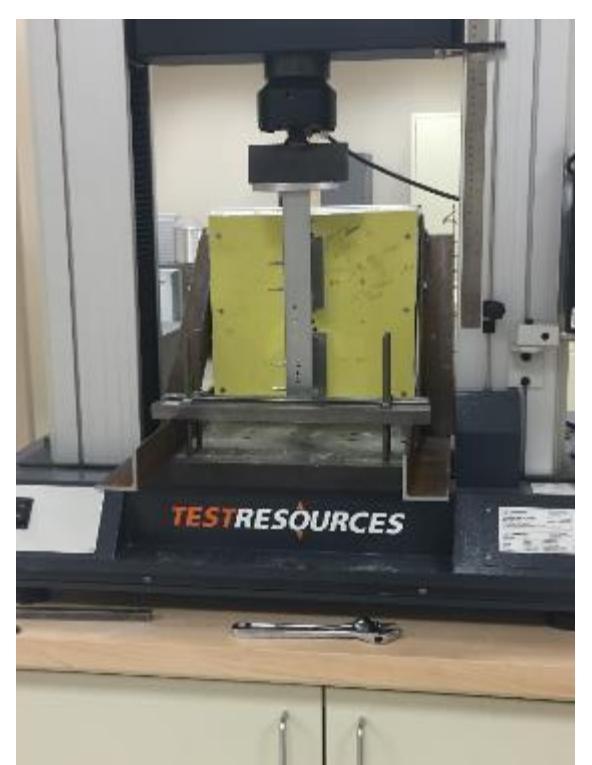
Photo No. 7 - TRUE CLIP AND GIRT (Typical Setup)

Two specimens for each of the TRUE Ci CLIP AND GIRT and Clip ONLY configurations were tested. All specimens were attached to a 12" x 12" wall section fabricated from 16 ga., 6" steel studs sheathed with Densglass. All specimens were tested without insulation between the Girt and the Densglass.

The specimens were loaded into a Test Resources universal test machine Model 312 Series Frame with a Q Controller (Asset #00217). A vertically downward load was applied at a rate of 0.10 inches per minute utilizing a 5-1/4" by 2" by 5/16" steel plate that was affixed into a 5600 lbf load cell (Asset #00226). In order to distribute load onto each specimen a 4-1/4" by 3-1/2" by 3/8" flat steel plate was placed on the loading face of each specimen.

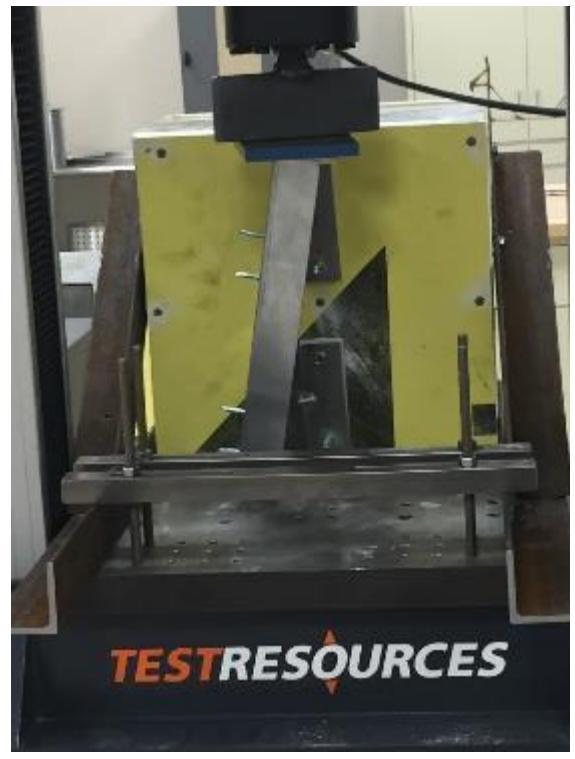
Photo No. 8 - TRUE CLIP AND GIRT (Specimen #1 - Failure)

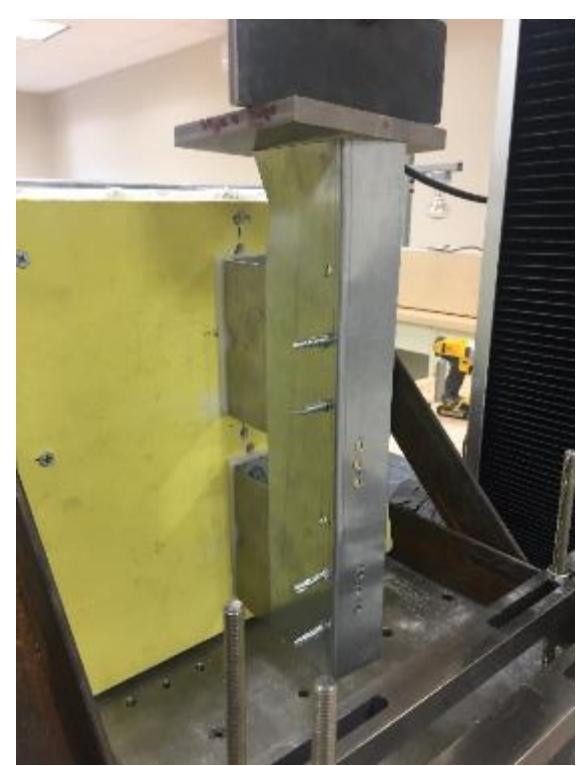
Photo No. 9 - TRUE CLIP AND GIRT (Specimen #2 – Failure)

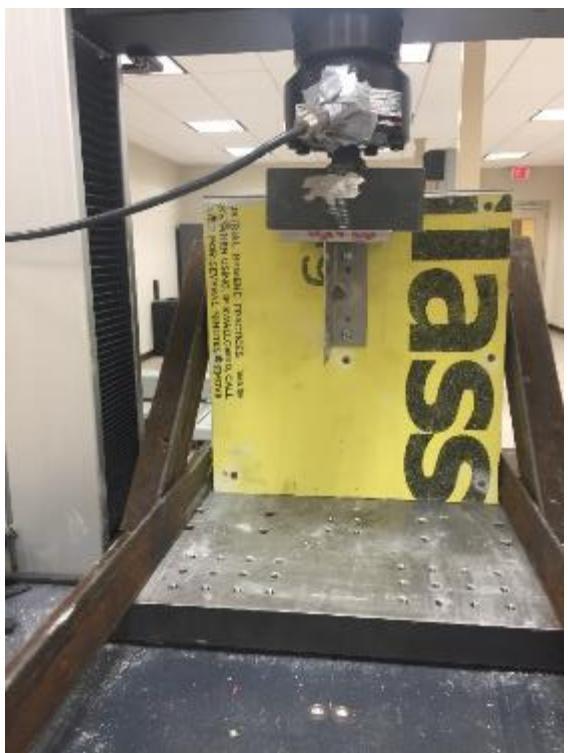
Photo No. 10 - TRUE CLIP AND GIRT Clip ONLY (Typical Setup)

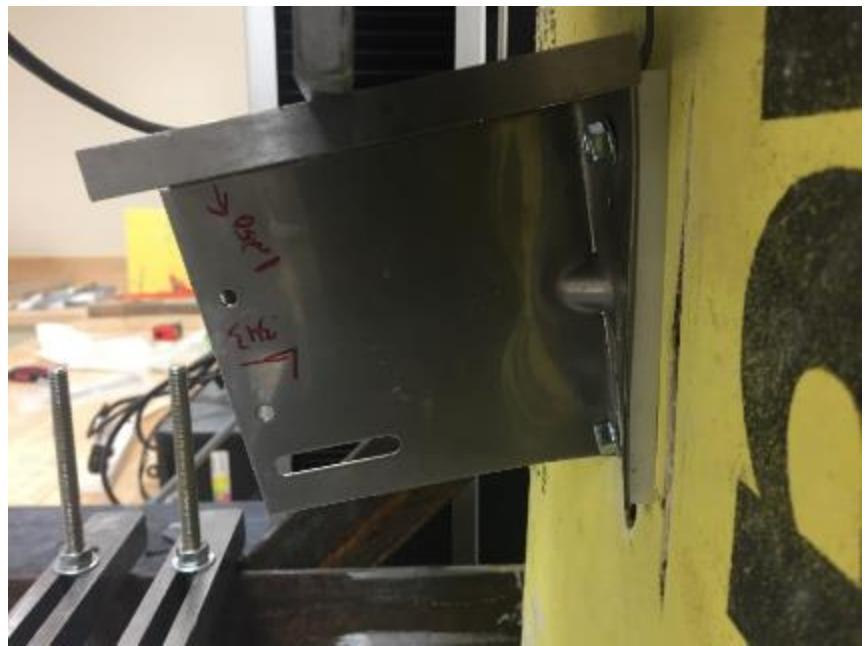
Photo No. 11 - TRUE CLIP AND GIRT Clip Only (Specimen #1 – Failure)

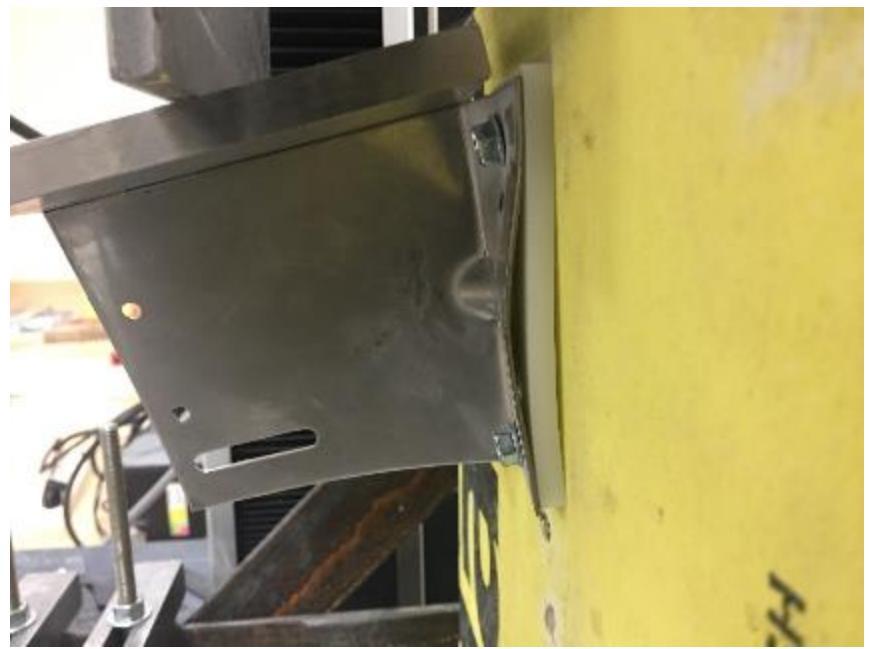
Photo No. 12 - TRUE CLIP AND GIRT Clip ONLY (Specimen #2 – Failure)

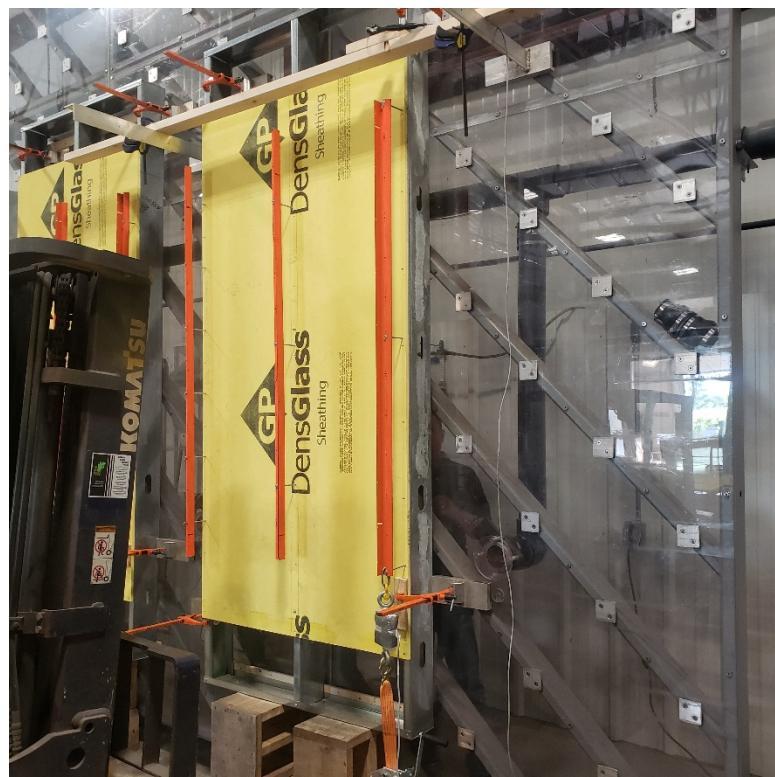
Photo No. 13 – Typical Full-Scale Test Setup (True Ci Vertical Girt Shown)

Testing was performed on the True Ci Vertical Girt, True Ci Horizontal Girt (installed vertically), 1" square aluminum tube, and an un-named competitor's product. All specimens were installed onto 16 ga, 6" steel stud walls sheathed with 1/2" Densglass. One specimen of each type was installed for testing. All specimens were spaced off the to simulate the presence of 2" or 4" insulation. All specimens installed to simulate 2" insulation utilized 1/4" diameter x 5" long hex head self-drilling screws (McMaster-Carr Part No. 91324A103) and all specimens installed to simulate 4" insulation utilized 1/4" diameter x 8" long hex head self-drilling fasteners (McMaster-Carr Part No. 91324A105).

The load was applied vertically downward by bolting to the bottom of the vertical rail and pulling downward. The vertical deflection of the rail was measured throughout the load application process. The load was applied at an average speed of 100-150 lb/second. All specimens were loaded using a forklift and come along utilizing a wire rope.

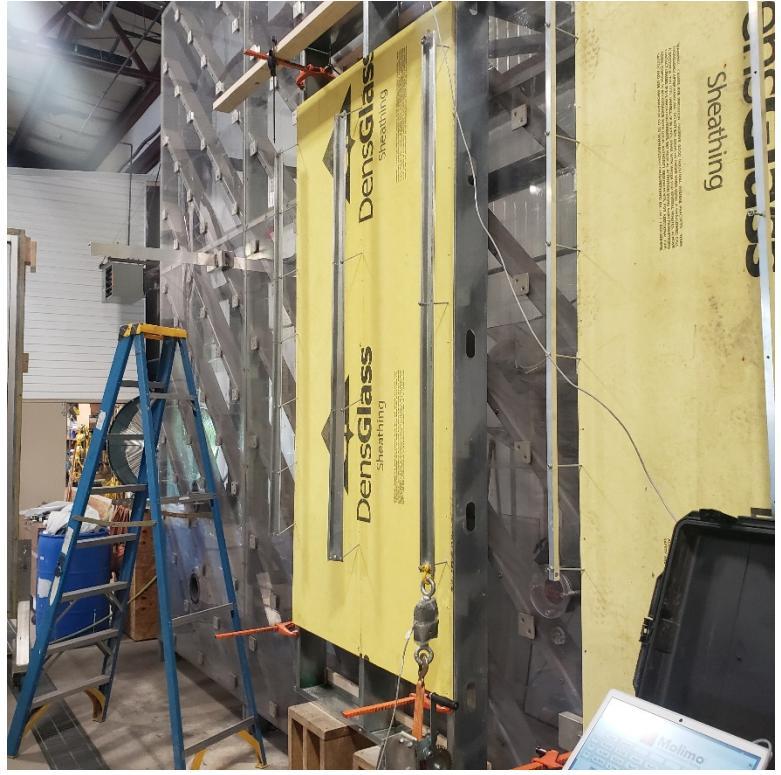
Photo No. 14 – Full-Scale Test Setup (True Ci Horizontal Girt Shown)

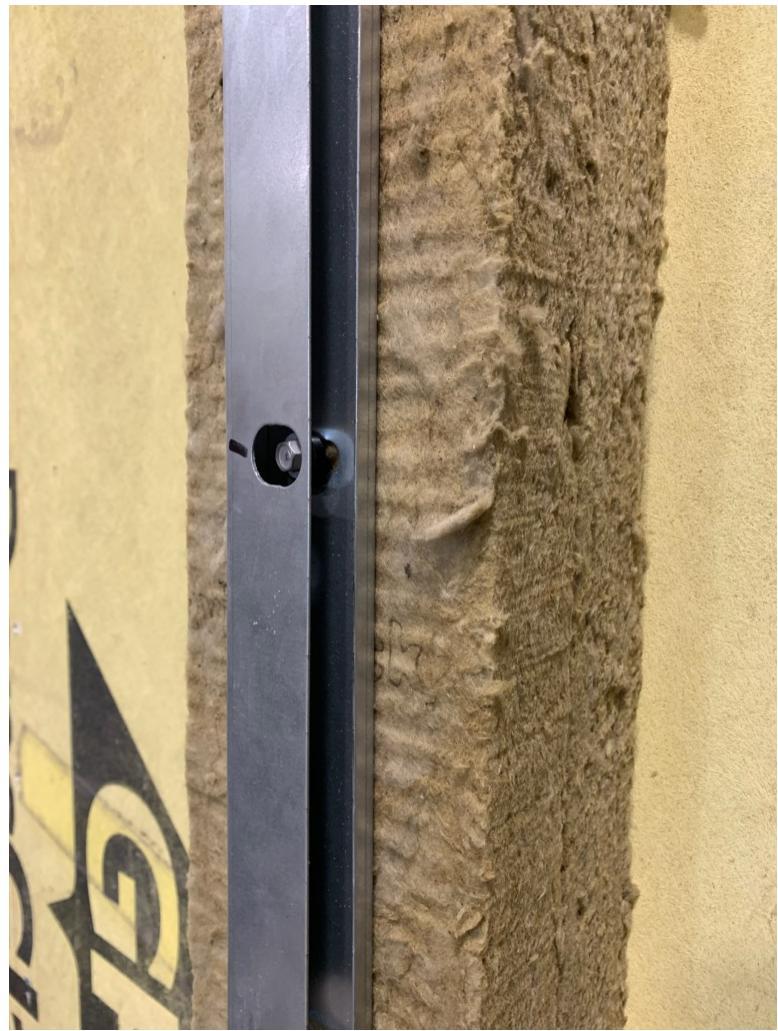
Photo No. 15 – Full-Scale Test Setup (Competitor's Product Shown)

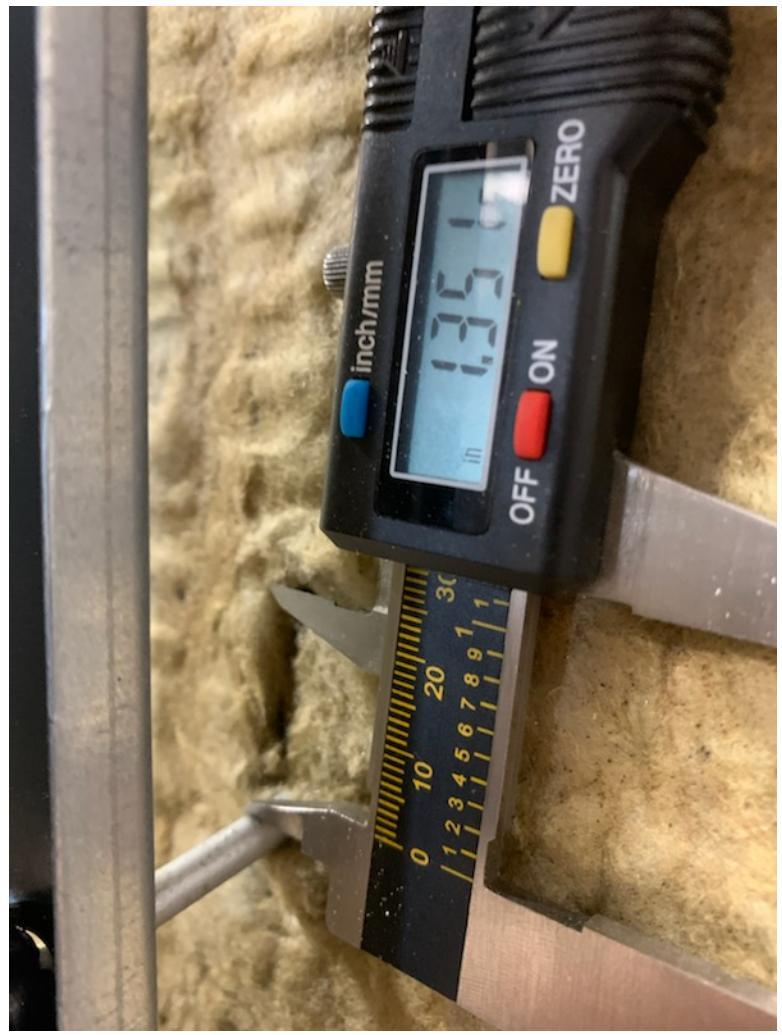
Photo No. 16 – Indentation of the Insulation - Full-Scale Test (Competitor's Product Test #2 Shown)

Note #2: Testing of the competitor's product did not result in yielding or bending of the fastener. However, the insulation suffered a bearing failure as a result of the applied load.

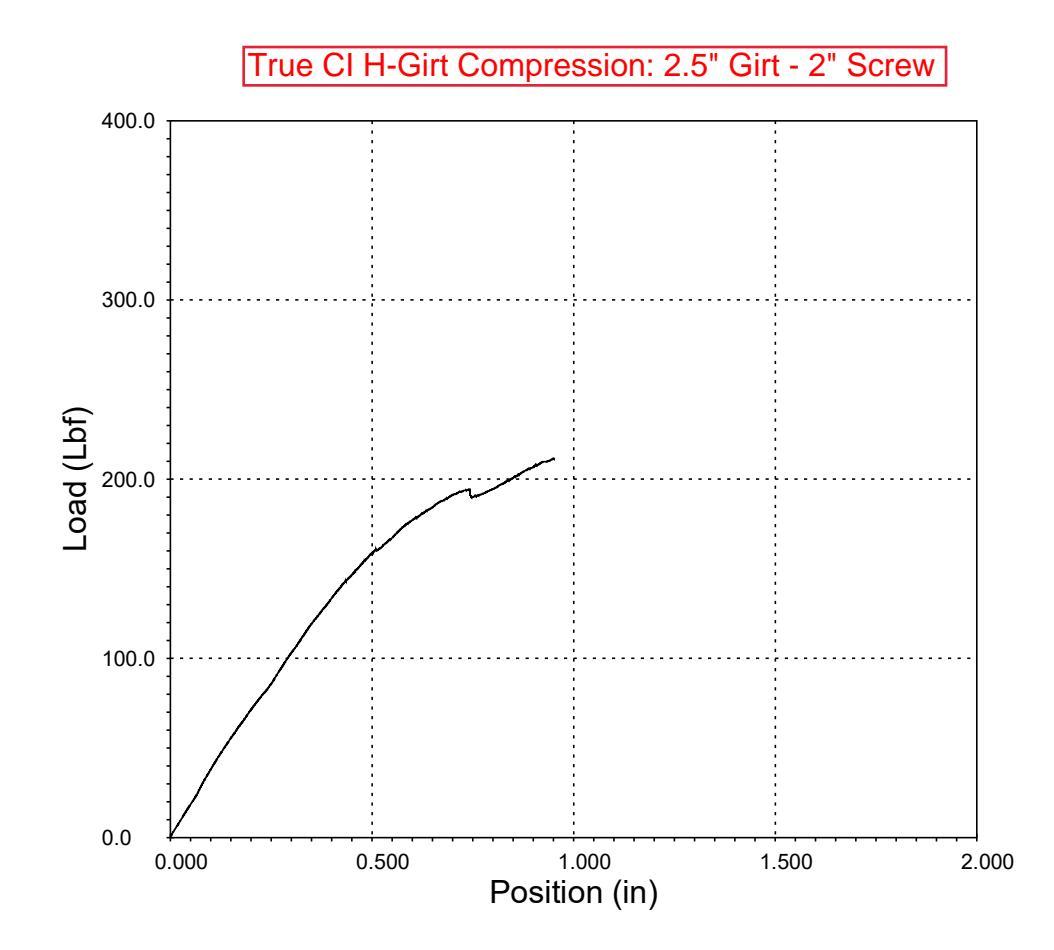
Date: Time: Specimen ID#: Direction: Specimen Type:	06/11/20 13:20:42 3-2 COMPRESSION None
Status: MAXIMUM LOAD	PASS
Result(Lbf):	211.65,
Disp1(in):	0.0000
Disp2(in): LOAD AT BREAK	0.0000
Result(Lbf): DISP AT BREAK	211.65,
Result(in):	0.9538,

Load at 0.125": 47 lbf

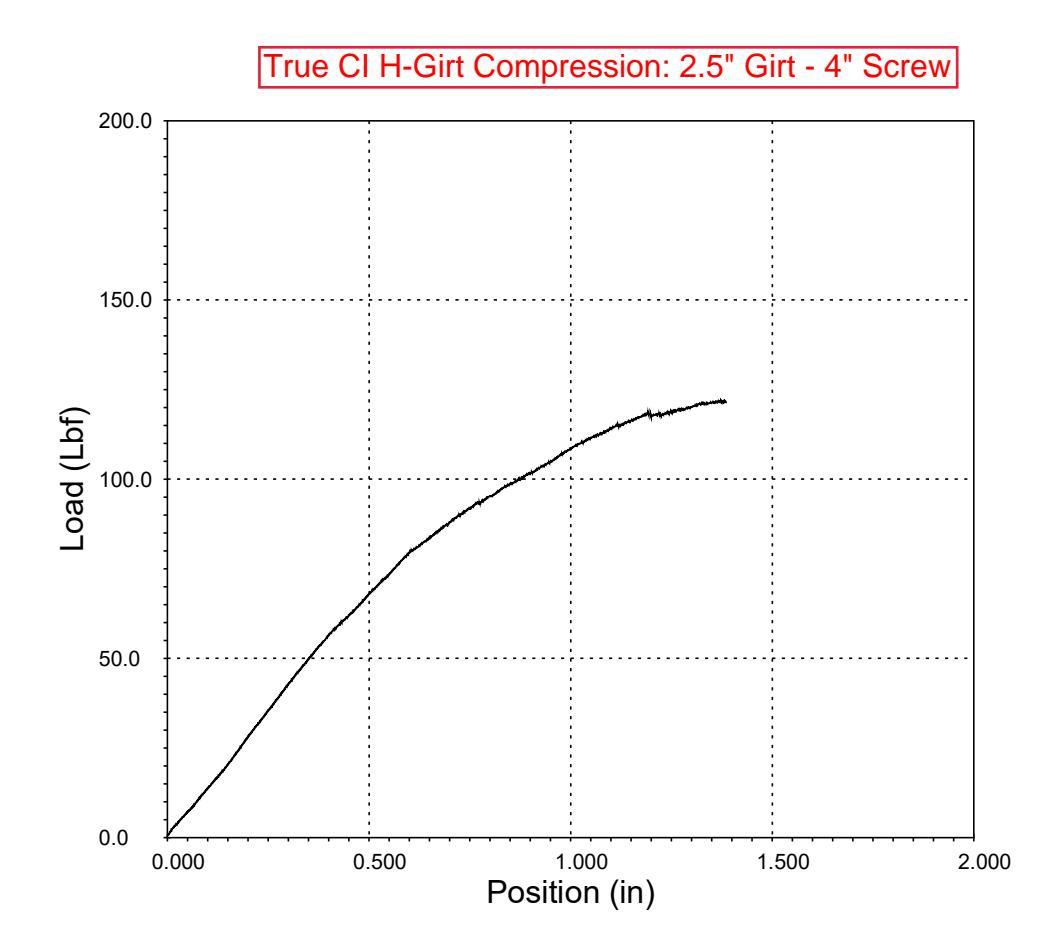
Date: Time: Specimen ID#: Direction: Specimen Type	06/11/20 14:20:12 4-6 COMPRESSION e: None
Status: MAXIMUM LO	PASS
Result(Lbf):	121.79,
Disp1(in):	0.0000
Disp2(in): LOAD AT BRE	0.0000 AK
Result(Lbf): DISP AT BREA	121.73, K
Result(in):	1.3865,

Load at 0.125": 17 lbf

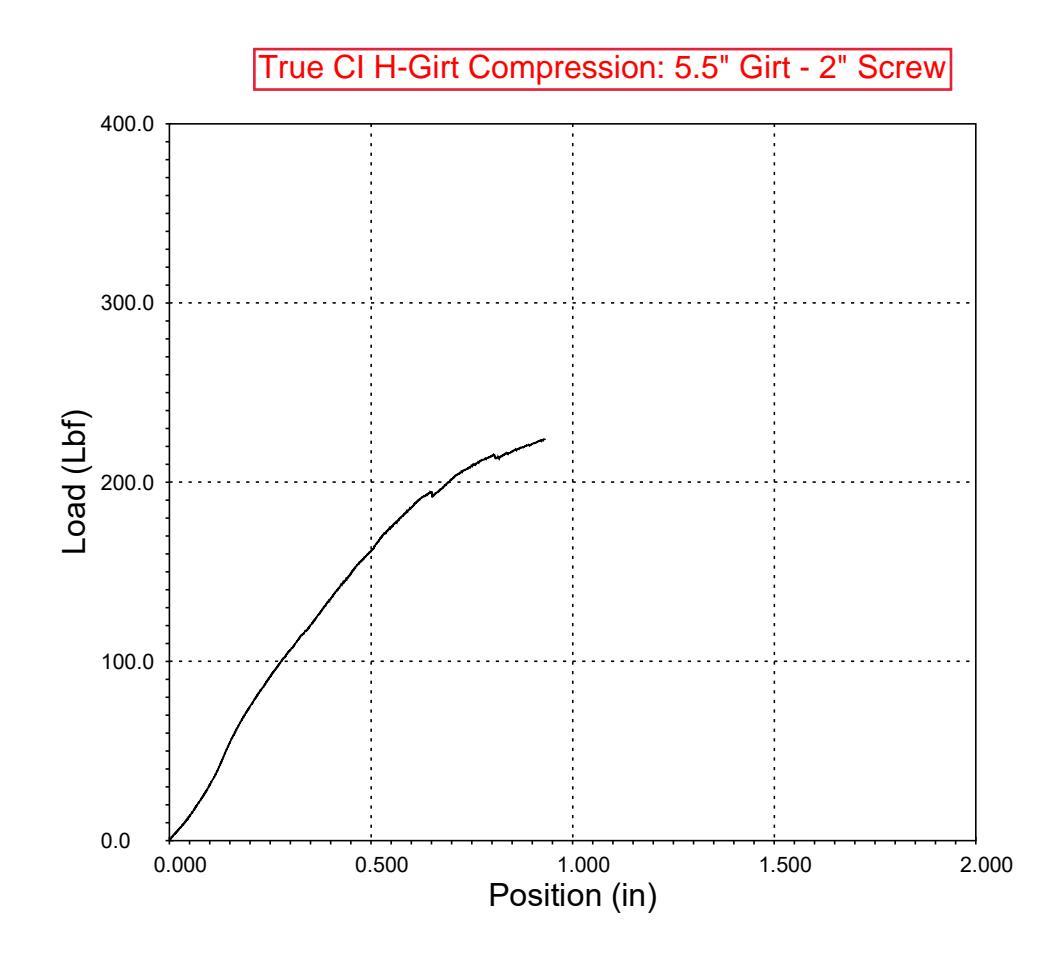
Date: Time: Specimen ID#: Direction: Specimen Type:	06/11/20 09:47:02 1-2 COMPRESSION None
Status: MAXIMUM LOAD	PASS
Result(Lbf):	224.12,
Disp1(in):	0.0000
Disp2(in):	0.0000
LOAD AT BREAK	
Result(Lbf):	224.12,
Load at 0.125": 42	lbf

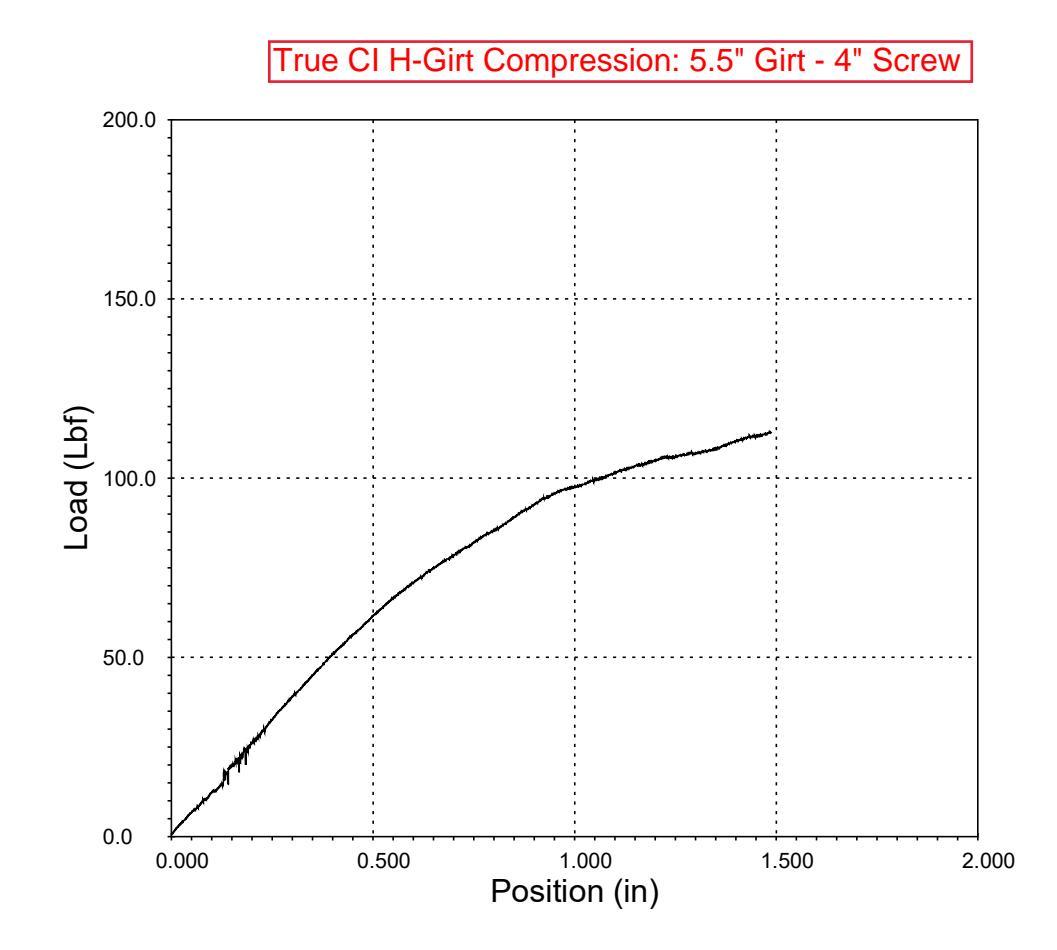
Date: Time: Specimen ID#: Direction: Specimen Type:	06/11/20 10:51:21 2-4 COMPRESSION None	
Status: MAXIMUM I QAD	PASS	
Result(Lbf):	112.80,	
Disp1(in):	0.0000	
Disp2(in):	0.0000	
LOAD AT BREAK		
Result(Lbf):	112.80,	
DISP AT BREAK Result(in):	1.4903,	
Load at 0.125": 15 lbf

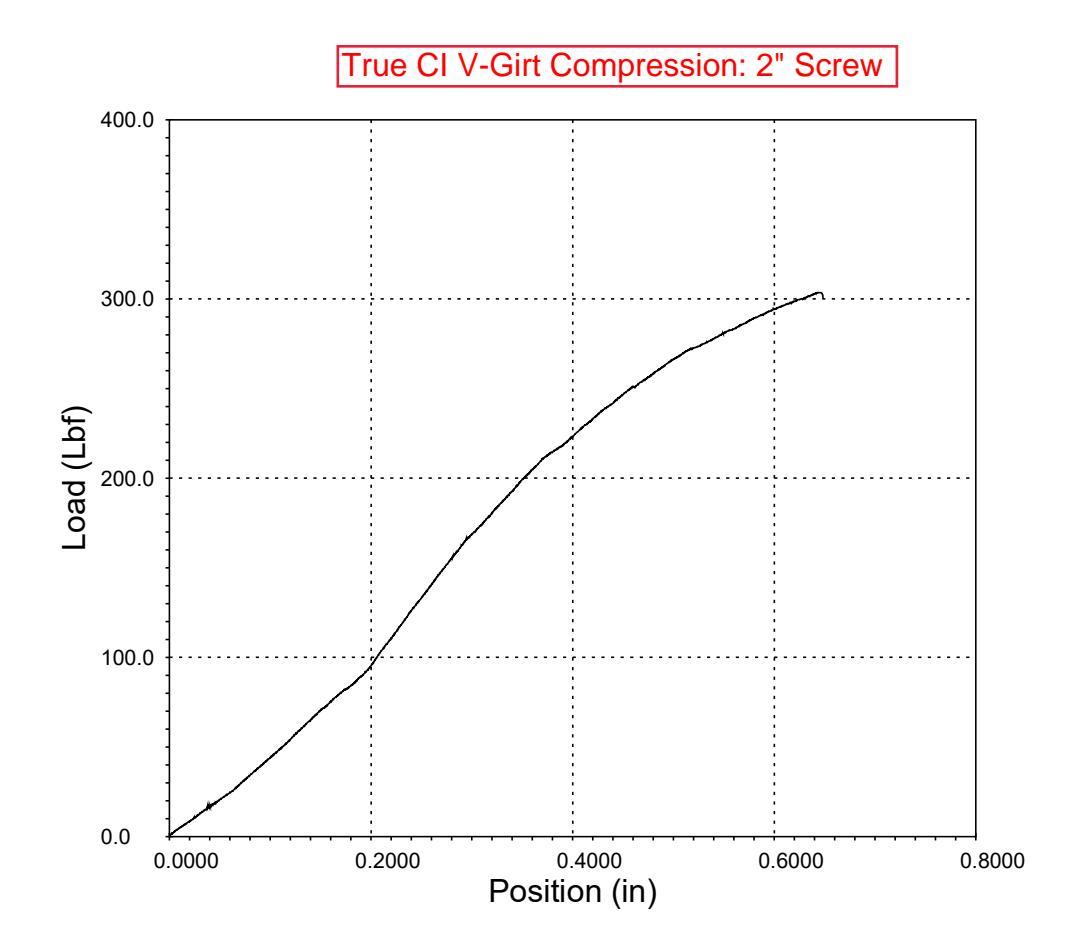
Date: Time: Specimen ID#: Direction: Specimen Type:	06/11/20 15:28:30 5-2 COMPRESSION None
Status: MAXIMUM LOAD	PASS
Result(Lbf):	303.54.
Disp1(in):	0.0000
Disp2(in):	0.0000
LOAD ÀT BREAK	
Result(Lbf):	300.26,
DISP AT BREAK	
Result(in):	0.6486,

Load at 0.125": 57 lbf

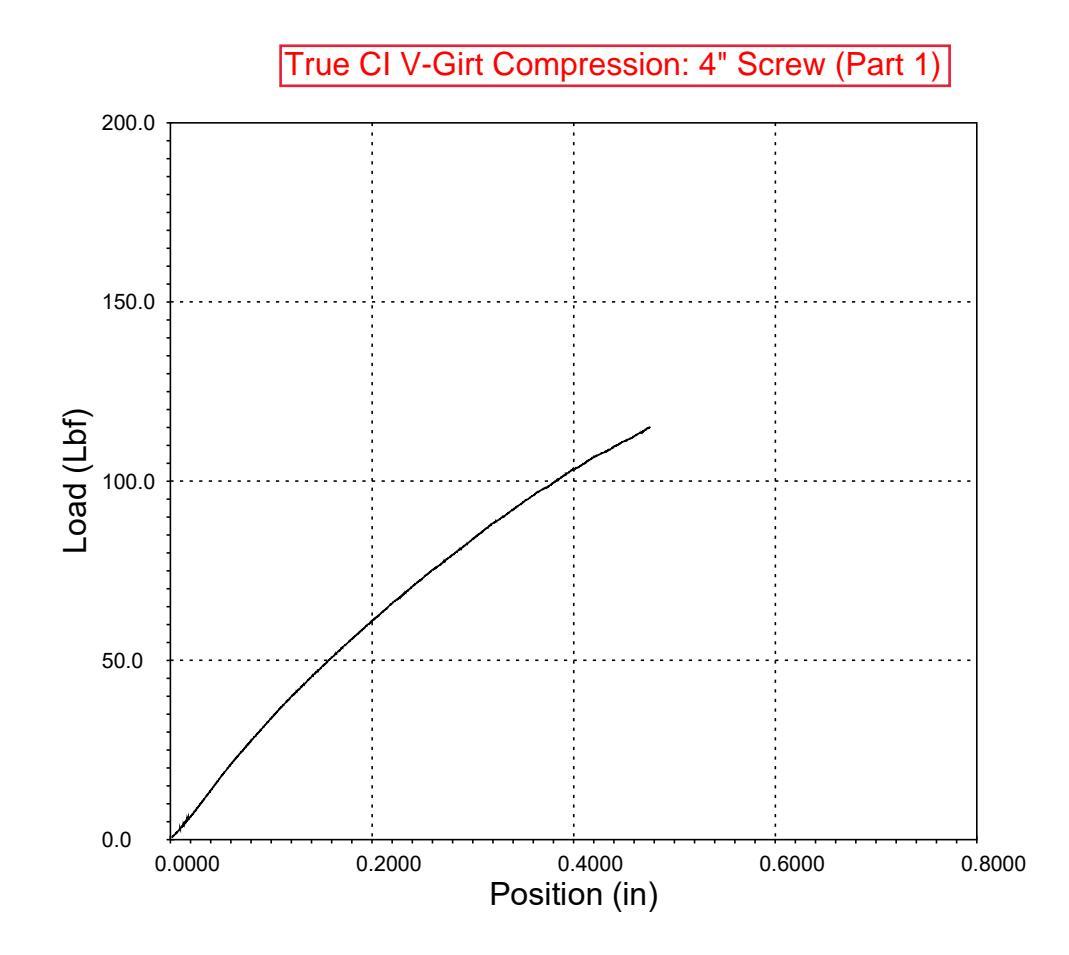
Date: Time: Specimen ID#: Direction: Specimen Type:	06/11/20 15:50:07 6-4 COMPRESSION None
Status: MAXIMUM LOAD	PASS
Result(Lbf):	115.10,
Disp1(in):	0.0000
Disp2(in):	0.0000
LOAD AT BREAK	
Result(Lbf):	115.10,
DISP AT BREAK	
Result(in):	0.4763,

Load at 0.125": 41 lbf

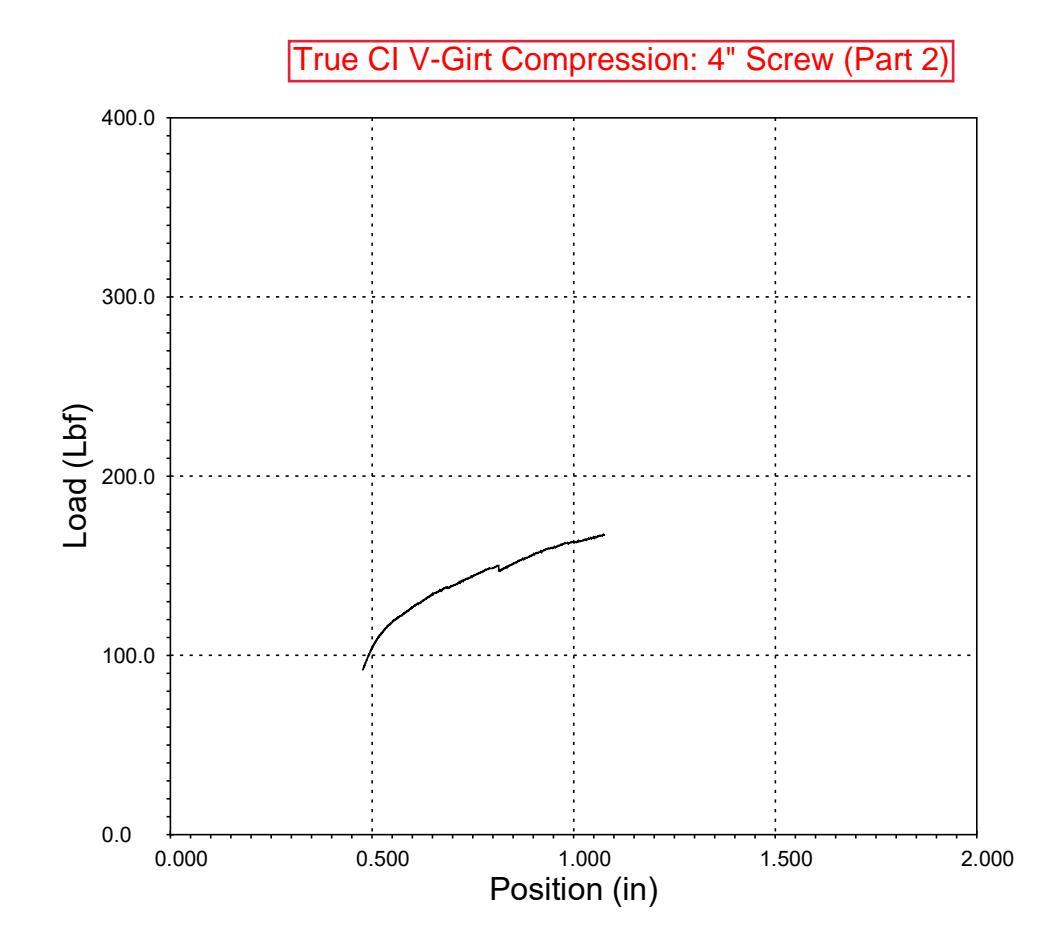
Date: Time: Specimen ID#: Direction: Specimen Type:	06/11/20 15:56:52 6-4 COMPRESSION None
Status: MAXIMUM LOAD	PASS
Result(Lbf):	167.31,
Disp1(in):	0.0000
Disp2(in):	0.0000
LOAD AT BREAK	
Result(Lbf):	167.31,
DISP AT BREAK	
Result(in):	1.0774,

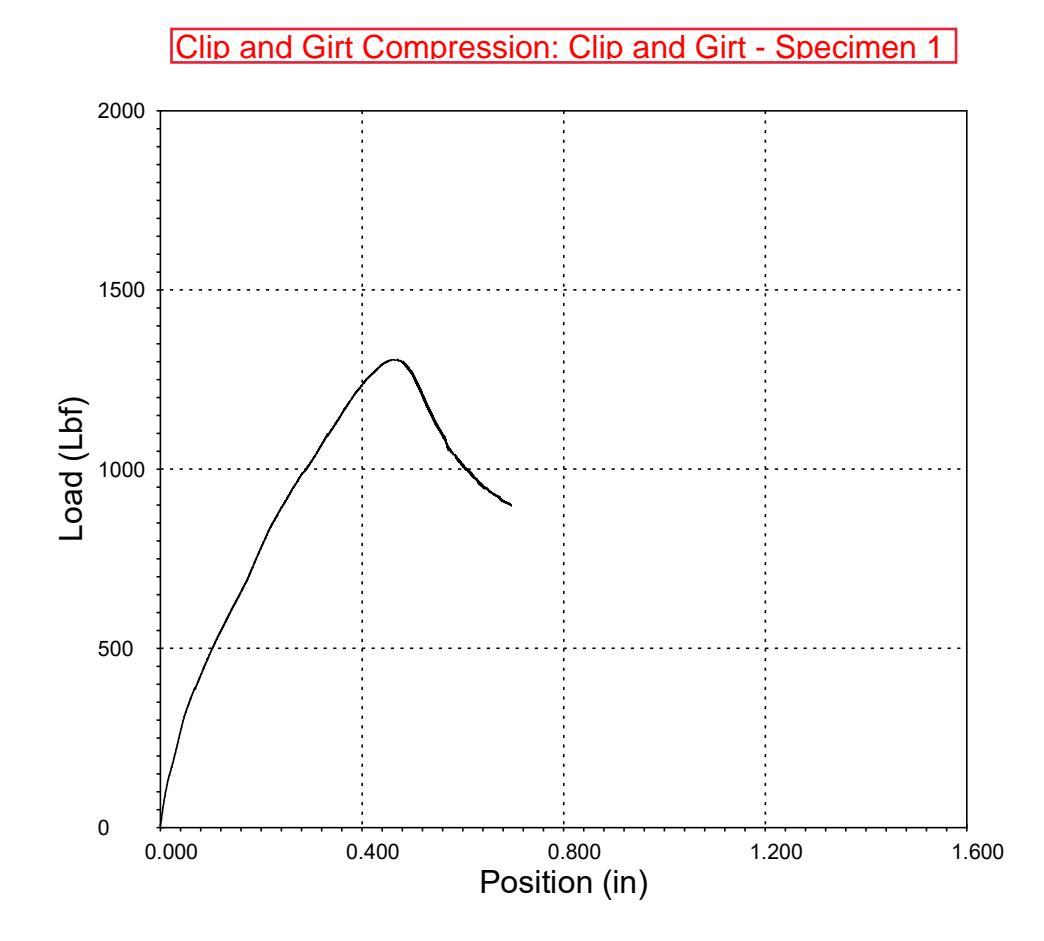
Date: Time: Specimen ID#: Direction: Specimen Type:	06/16/20 15:09:01 8-1 COMPRESSION None
Status: MAXIMUM LOAD	PASS
Result(Lbf):	1305.23,
Disp1(in):	0.0000
Disp2(in):	0.0000
LOAD AT BREAK	
Result(Lbf):	899.07,
DISP AT BREAK	
Result(in):	0.6969,

Load at 0.125": 561 lbf

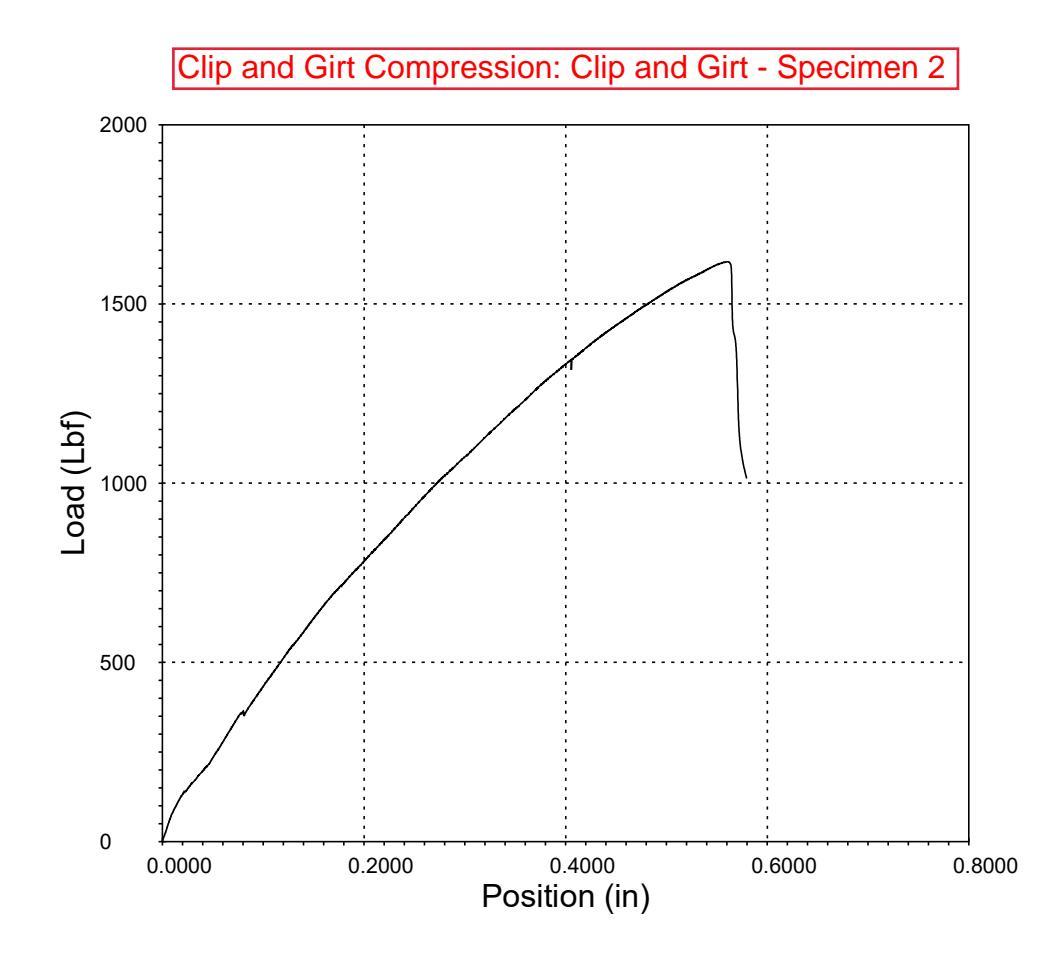
Date: Time: Specimen ID#: Direction: Specimen Type:	06/17/20 11:37:03 8-1 COMPRESSION None
Status:	PASS
Result(Lbf):	1617.39.
Disp1(in):	0.0000
Disp2(in):	0.0000
LOAD AT BREAK	
Result(Lbf):	1013.19,
DISP AT BREAK	0.5700
Result(in):	0.5798,
Load at 0.125": 531 lbf

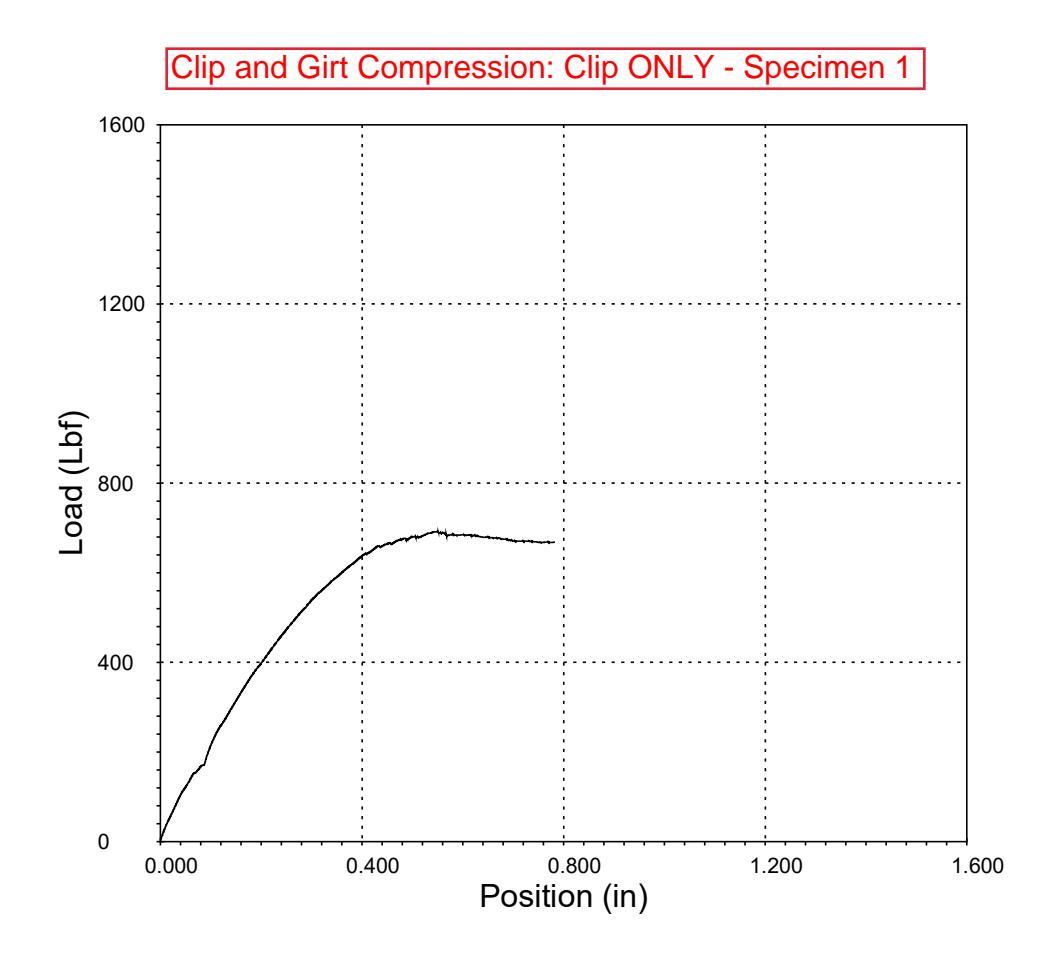
Date: Time: Specimen ID#: Direction: Specimen Type:	06/17/20 14:13:09 9-1 COMPRESSION None
Status: MAXIMUM LOAD	PASS
Result(Lbf):	691.86,
Disp1(in):	0.0000
Disp2(in):	0.0000
LOAD AT BREAK	
Result(Lbf):	668.11,
DISP AT BREAK Result(in):	0.7839,

Load at 0.125": 266 lbf

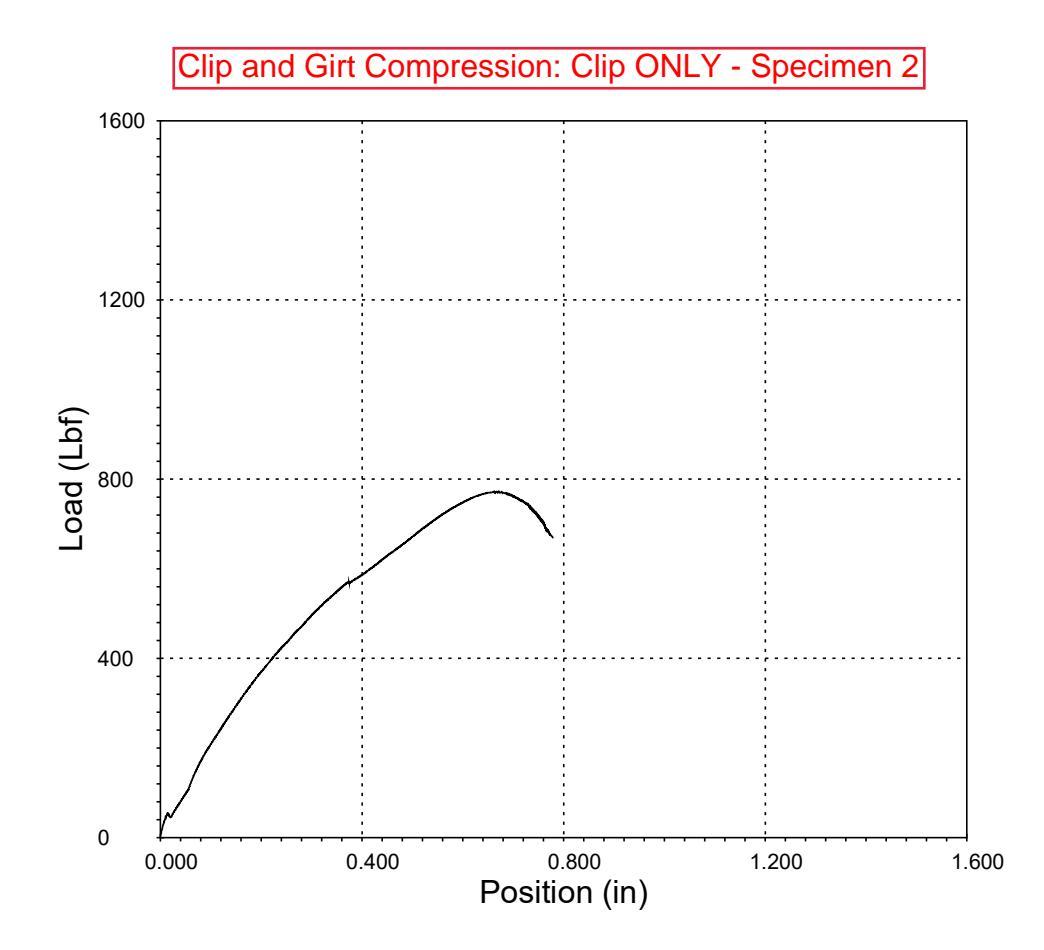
Date: Time: Specimen ID#: Direction: Specimen Type:	06/17/20 14:47:22 9-2 COMPRESSION None
Status:	PASS
Result(Lbf):	770.89.
Disp1(in):	0.0000
Disp2(in):	0.0000
LOAD AT BREAK	
Result(Lbf):	667.98,
DISP AT BREAK	
Result(in):	0.7802,
Load at 0.125": 251 lbf
